ANDROSCOGGIN RIVER BASIN
NORTH WAYNE , MAINE

LOVEJOY POND DAM ME-00022

PHASE I INSPECTION REPORT NATIONAL DAM INSPECTION PROGRAM

APRIL 1979

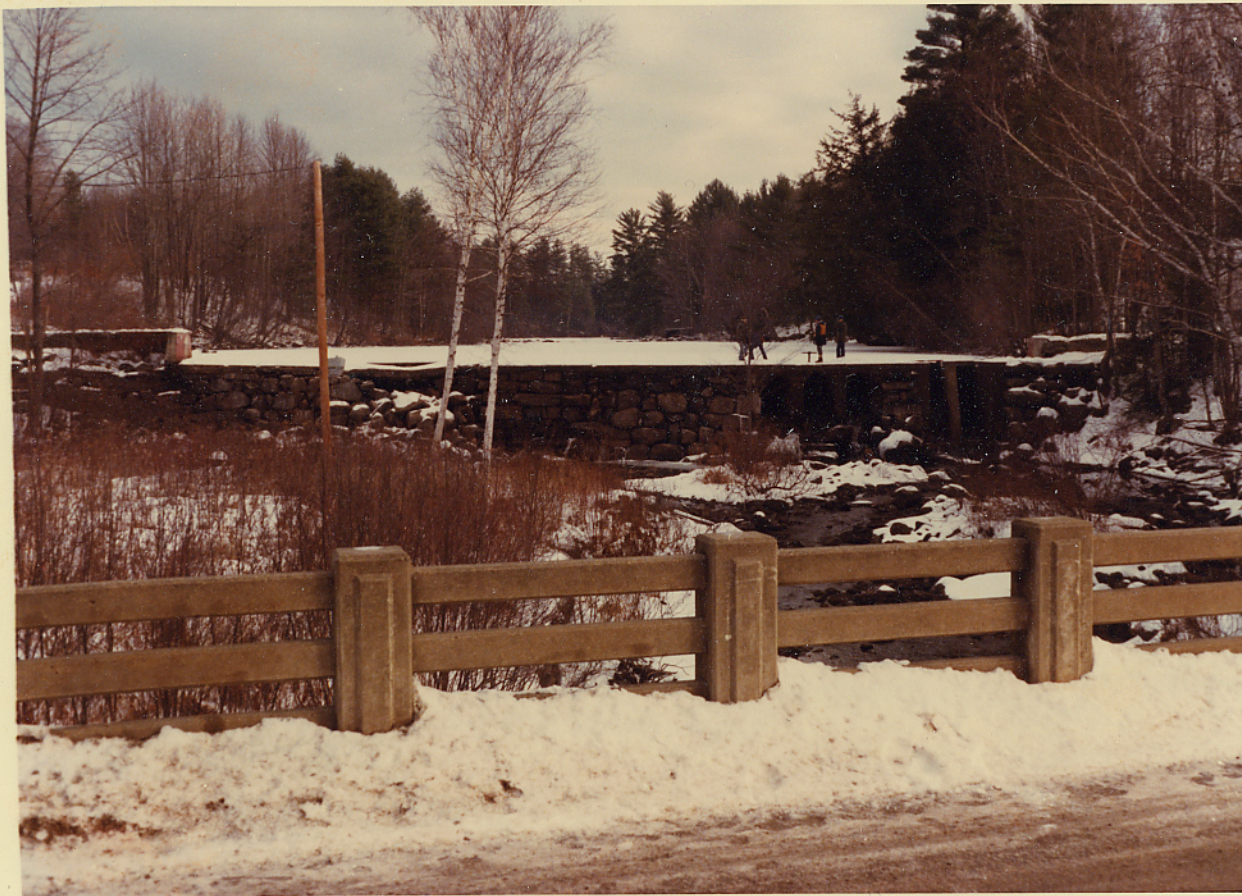
OVERVIEW

- (c) The spillway consists of a concrete cap overlying unbound stone masonry. Heavy leakage is occurring through the concrete and the masonry face. The concrete surface is cracked in several areas and there are several holes through the concrete. The supporting masonry has tumbled downstream in one area allowing the crest slab to collapse (see photographs #3 and #7 and overview).

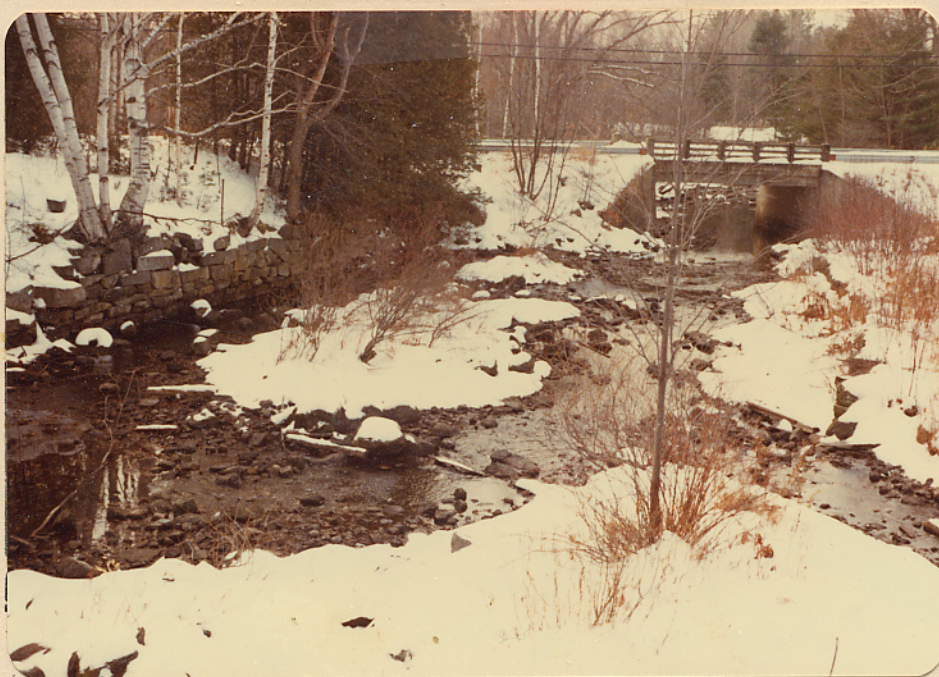
2

VIEW DOWNSTREAM

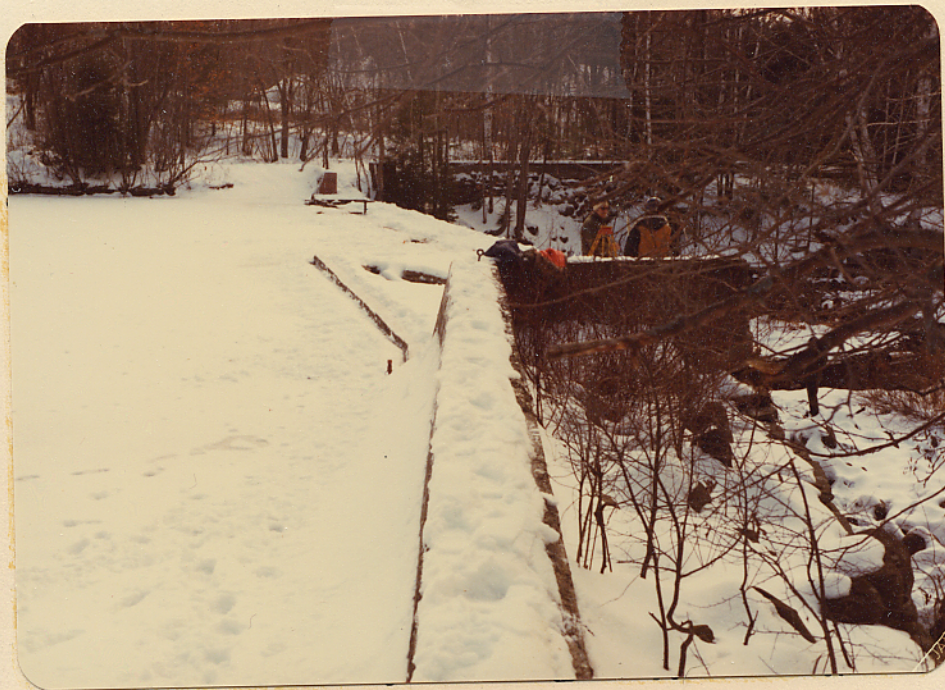
3

- (a) The abutments of the dam appear to be in good condition with no evidence of settlement, movement, or leakage observed during the inspection.
 - (b) The spillway section of the dam is bordered by concrete wingwalls at each end. The walls were constructed above the dry-laid stone masonry portion of the dam. The masonry appears to be in good condition, however, the concrete walls are in fair to poor condition. The west concrete wall is cracked, spalled, and its junction with the spillway is in poor condition. Some brush is growing in the masonry downstream of the wingwall. The east wingwall is in poor condition. The concrete surface is badly spalled and several holes exist through the wall. Trees and brush are growing in the masonry downstream of the wall (see photograph #3).

DAM CREST FROM WEST END

- (1) Repair all spalled and cracked concrete surfaces including reconstruction of the east wingwall and portions of the spillway crest.
- (2) Clear trees and brush from the masonry portions of the dam below the wingwalls.
- (3) Provide around-the-clock surveillance during periods of anticipated high runoff.
- (4) Have inspections of the dam made by a registered professional engineer once every year.

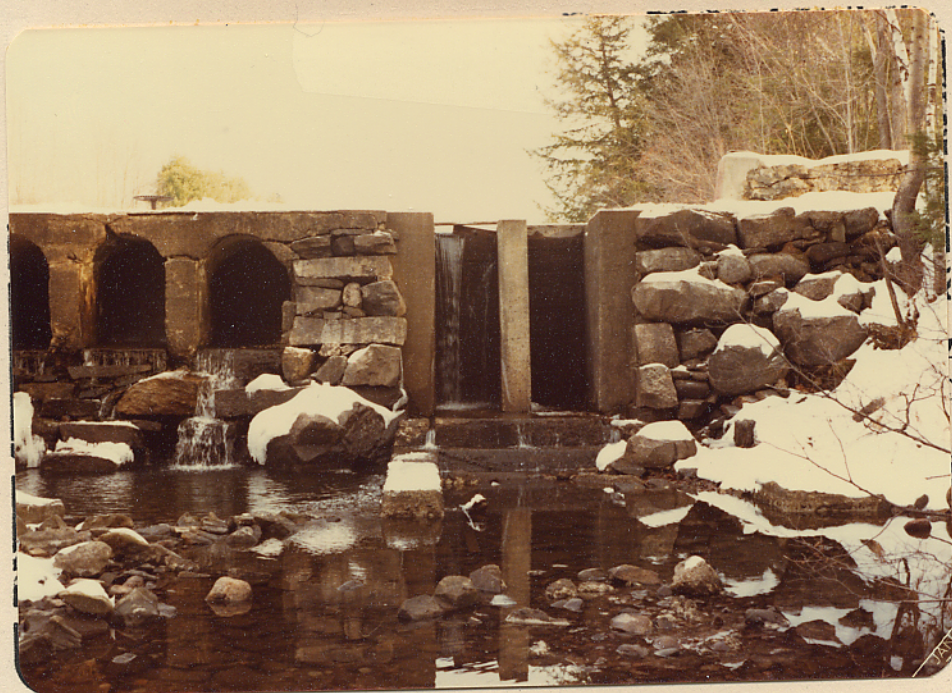
4

EASTERLY STOP LOG OUTLET

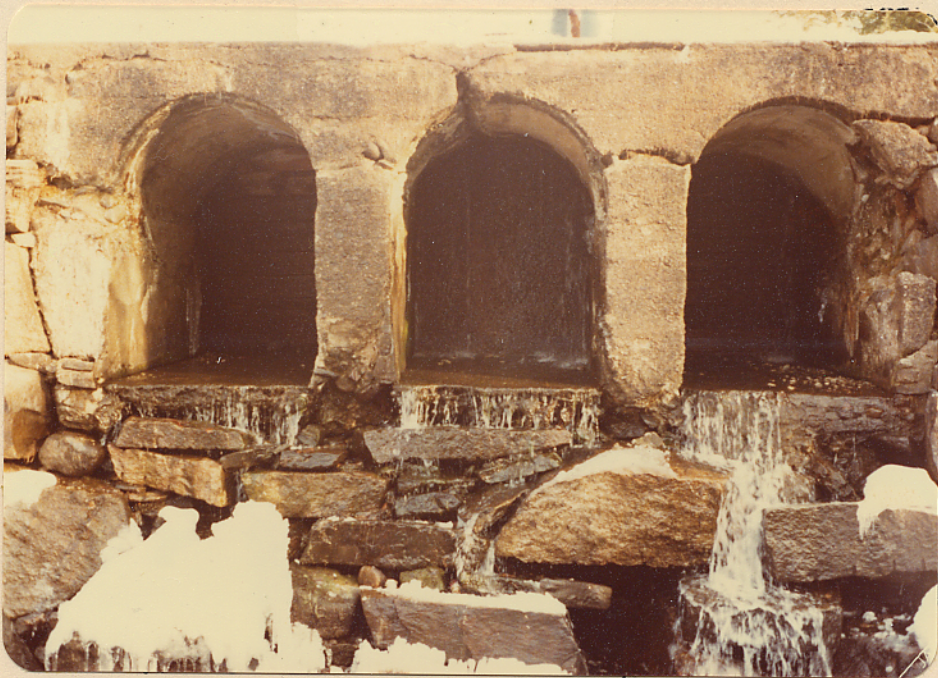
5

- (d) The low level pond drain consists of a stone masonry sluiceway which appears to be in good condition. The gated outlet works, located below the spillway, are in poor condition (see photograph #5). The east and west outlet have been closed by stop logs. The concrete is severely spalled, cracked and eroded. Some leakage is occurring into the conduits.

GATED OUTLET (CENTER) AND STOP LOG OUTLETS (LEFT & RIGHT)
WITH LOW LEVEL OUTLET AT BOTTOM

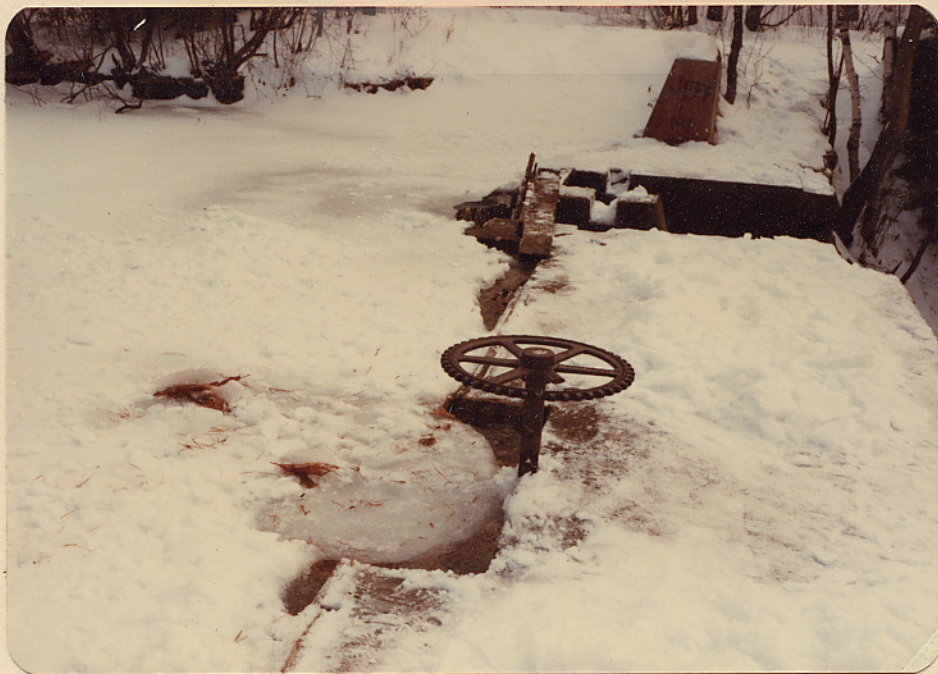
6

EAST ABUTMENT

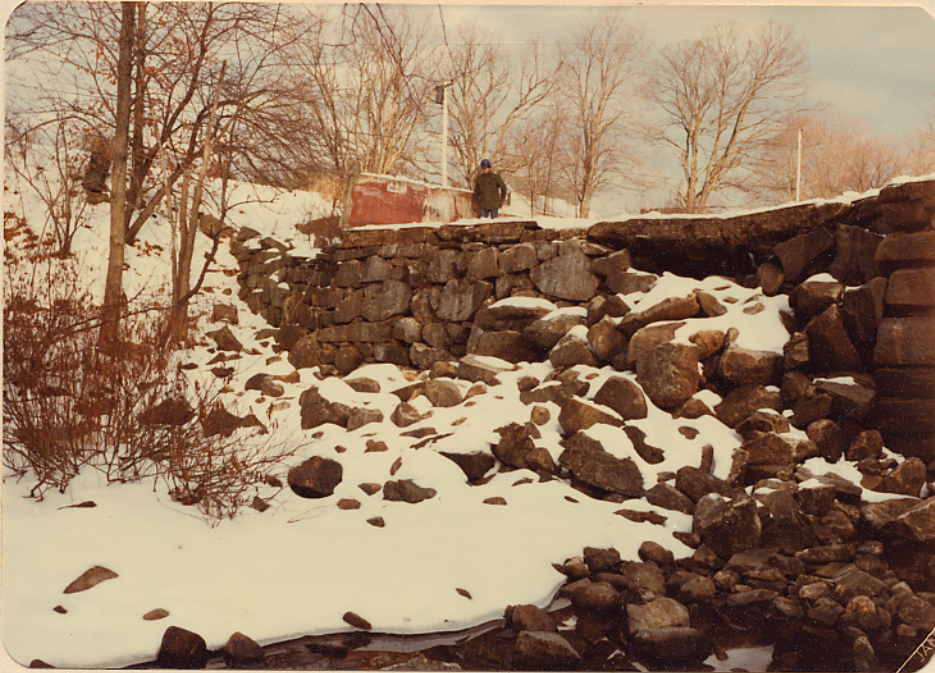
7

- (1) The stone masonry which forms the downstream face of the spillway and forms the support for the spillway crest has been dislodged in one area resulting in the collapse of an 8-foot width of the spillway crest at that area (see photographs #3 and #7 and overview).
- (2) The concrete surfaces of the spillway, wingwalls, and gated outlet sluiceways are in poor condition (see photograph #5).
- (3) Heavy leakage is occurring through the masonry below the spillway section of the dam.
- (4) The outlet works which are located in the central portion of the dam beneath the spillway would be inaccessible during flood conditions. Four of these outlets are closed by stop logs and a fifth outlet is closed by an inoperable butterfly gate.

Stone Masonry Surfaces. The downstream face, both wingwalls and spillway sections of the dam, is constructed of dry-laid stone masonry. The surface of this masonry was found to be generally tight. However, a large area of the westerly spillway has toppled and is now lying downstream of the dam. The remaining masonry in this area is very loose.

COLLAPSED AREA - DOWNSTREAM FACE

- (1) Curtailment of leakage through the dam.
- (2) Rehabilitation of the stone masonry and the spillway crest.
- (3) Provisions for energy dissipation and scour protection below the spillway and outlets.
